DEPARTMENT OF TRANSPORTATION**DIVISION OF ENGINEERING SERVICES**

Quality Assurance and Source Inspection

Contract #: 04-0120F4Cty: SF/ALA Rte: 80 PM: 13.2/13.9File #: 1.28**WELDING INSPECTION REPORT****Resident Engineer:** Siegenthaler, Peter**Address:** 333 Burma Road**City:** Oakland, CA 94607**Report No:** WIR-016999**Date Inspected:** 24-Sep-2010**Project Name:** SAS Superstructure**OSM Arrival Time:** 900**Prime Contractor:** American Bridge/Fluor Enterprises, a JV**OSM Departure Time:** 1730**Contractor:** American Bridge/Fluor Enterprises, a JV**Location:** Job Site

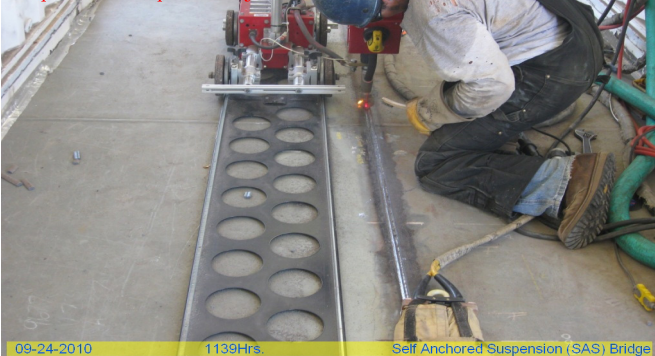
At OBG 6W/7W top deck plate 'A' outside, ABF welder Mike Madan was observed performing Submerged Arc Welding (SAW) welding fill pass on the splice butt joint.

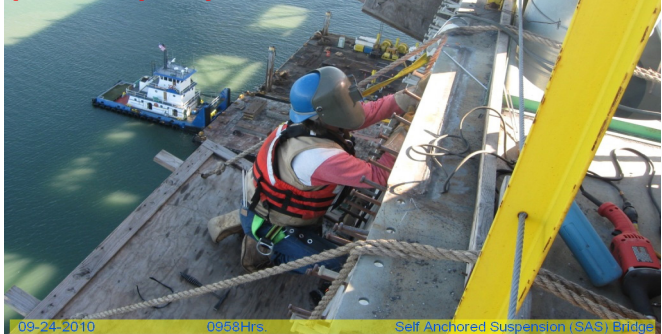
At OBG 3W top deck 'A' outside/north, ABF welder Eric Sparks was observed performing 4G Shielded Metal Arc Welding (SMAW) on the corner CJP of the 3 5/8" wide x 3/8" thick counter weight connection plate to the top deck plate.
